รายละเอียดขั้นตอนการทดสอบ

ความสมบูรณ์ของเสาเข็ม

โดยวิธี **Seismic Test**

## รายงานผลการตรวจสอบความสมบูรณ์ของเสาเข็ม

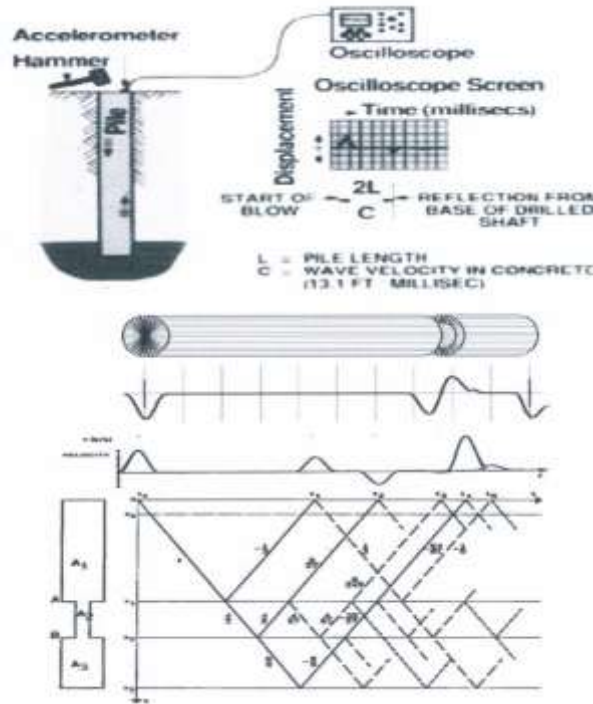
แผนภูมิต่อไปนี้แสดงให้เห็นลักษณะการสะท้อนกลับของคลื่นและการแปรผล

เมื่อเสาเข็มทดสอบมีขนาดพื้นที่หน้าตัดเล็กลง หรือมีค่าโมดูลัสลดลง เมื่อเทียบกับหัว เสาเข็มสัญญาณคลื่นความเค้นอัดจากการทดสอบจะเกิดการสะท้อนกลับ ณ. จุดนี้ในรูปแบบของ คลื่นความเค้นดึง (Tension Wave) แสดงผลในรูปสัญญาณ “บวก” ในกราฟระหว่างความเร็ว กับเวลาในทำนองเดียวกันหากพื้นที่หน้าตัดเพิ่มขึ้นหรือค่าโมดูลัสเพิ่มขึ้นสัญญาณสะท้อนกลับ จะอยู่ในรูปของคลื่นความเค้นอัด (Compression Wave) แสดงผลในรูปสัญญาณ “ลบ” ตารางข้างทำยนี้ จะช่วยทำความเข้าใจในความสัมพันธ์ข้างต้นได้ดีขึ้น

พื้นที่หน้าตัด	โมดูลัส	อิมพีแดนซ์	สัญญาณสะท้อนกลับ	การแสดงผลในกราฟ ความเร็ว-เวลา
A	E	Z		
↑	คงที่	↑	Comp. Wave	ลบ
↓	คงที่	↓	Tension Wave	บวก
คงที่	↑	↑	Comp. Wave	ลบ
คงที่	↓	↓	Tension Wave	บวก

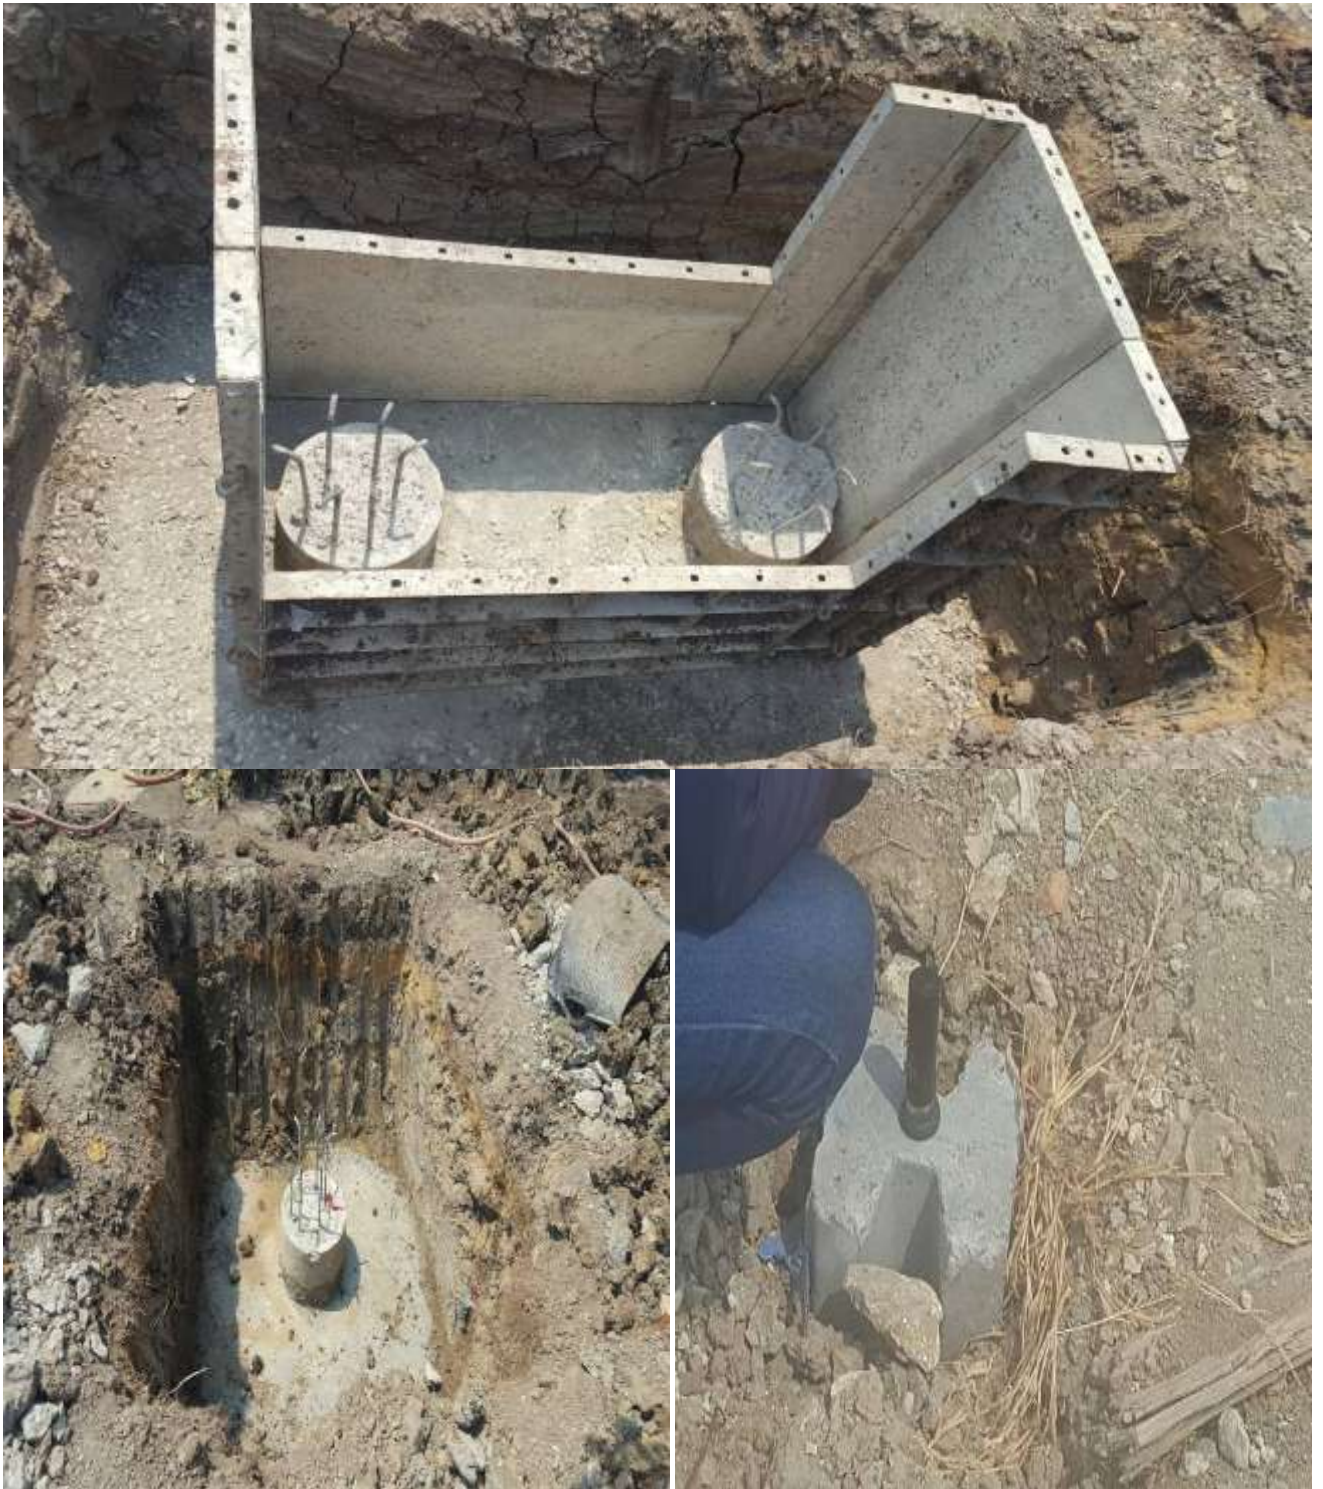
### รูปภาพหัวเสาเข็มที่ควรเตรียมก่อนการทดสอบ

3.1 หัวเสาเข็มจะต้องสะอาดและแห้งปราศจากตะกอนดิน ฝุ่นผงจากการสกัดตกแต่งหัวเสาเข็มและพื้นผิวควรเรียบเพียงพอที่จะติดตั้งหัววัดสัญญาณให้แนบสนิท

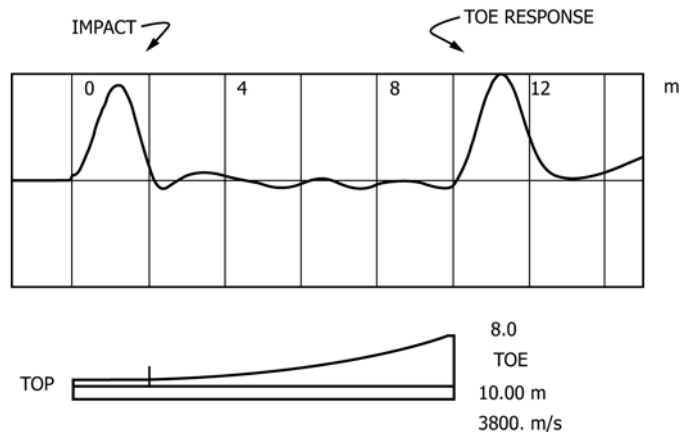
FIG. 1 Typical Velocity Traces for the Pulse Echo Method Generated by the Apparatus for Obtaining Dynamic Measurements (note the orientation of the input pulse is shown as positive in this standard; orientation could also be shown negative)

NOTE 2—It is recognized that the velocity signal may be drawn in either downward or upward positive amplitudes. The depth scale may be aligned either at the start of the rise (as shown) or at the initial peak. It is recommended that information be included in the plot showing the magnification function with time.

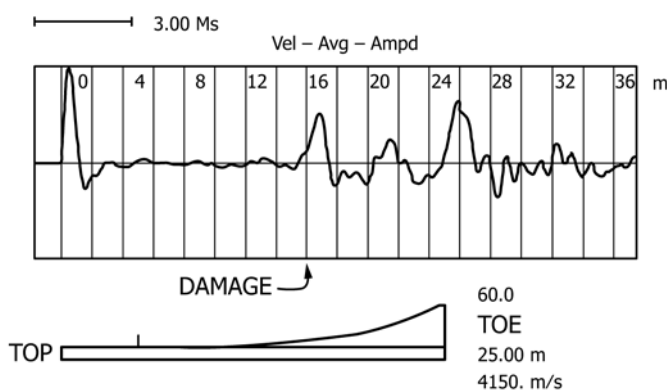
**FIG. 4 Typical Velocity Record Indicating Major Changes in Impedance (Severe Damage or a Cracked Pile (note the orientation of the input pulse is shown as positive in this standard; orientation could also be shown negative))**

NOTE 4—In the time domain analysis (PEM), base the pile integrity evaluation on relative increases and decreases of velocity after the initial impact pulse (Fig. 3, Fig. 4). Apparent reflections occurring prior to the toe response that are of the same sign as the input are due to a relative decrease of impedance. Reflections of the opposite sign are due to a relative increase of impedance. Comparison of results from several piles from the site with similar construction is recommended to assess the typical response with the same amplification factor being applied to all piles of similar lengths. Visual interpretation may be qualitative and possibly relative to other tested piles and a matter of proper engineering judgment.

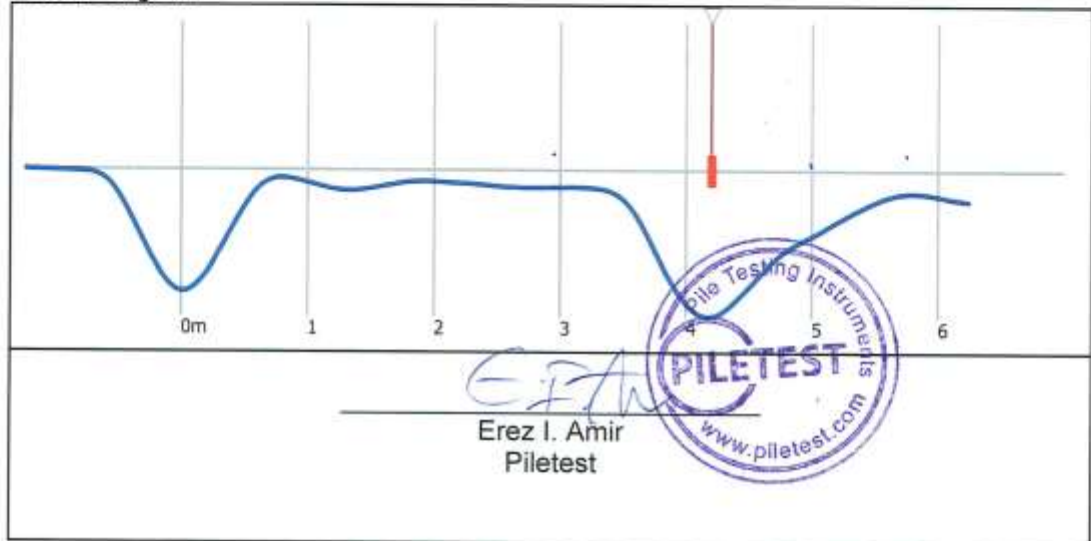
Reflectogram

Pile	Details	Length (m)	Remarks
<b>25584 - E3775</b>	2018-01-16 C:4000m/s Amp:1.0 F:0 Planned:4.2m Avg:20	4.2m	✓
